SA-04-02

# Langley Research Center Safety Alert

SUBJECT: Potential Hazard From Contaminated Ice Machines

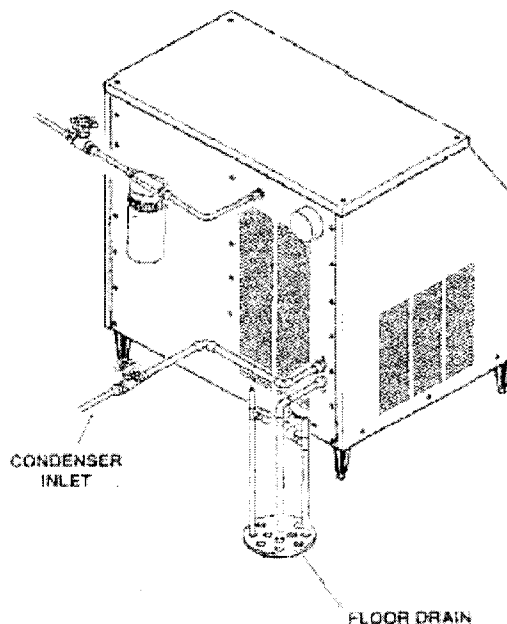
A recent inspection of several ice machines, at the Langley Research Center, by Systems Engineering Competency revealed improper drain line installation. A common drain line was used to drain both condensate from the chiller coils and liquid from melting ice in the ice bin. Connecting the two drain lines together allowed condensate from the chiller coils to enter the bottom of the ice bin resulting in mold growth in the ice bin.

Ensure that condensate  
and ice-bin drain lines are  
separate and are vented.

A vented drain line should be installed on the condensate drain for the chiller coils. A separate vented drain line should be installed on the liquid drain for the ice bin. Both drains should have a one (1") inch air gap where the lines terminate above the floor drain.

Facility Safety Heads and Facility Coordinators need to verify that any ice machines installed in their facilities are properly connected, with two separate vented drain lines for the drains on the chiller coils and ice bin. If you have any questions, please contact Rick Vogel at 47061.
